CHAPTER 4

BASELINE PHYSICAL ENVIRONMENT

The Project area of Karuma HPP is located in Kiryandonga and Oyam district of Uganda on the banks of river Kyoga Nile, on the Kampala-Gulu Highway and is thus well connected both from Kampala and Gulu. The river flows in South - North direction in its upper reaches from the origin, and then flows in East - West direction after Karuma falls. The main tributaries of Nile River up to

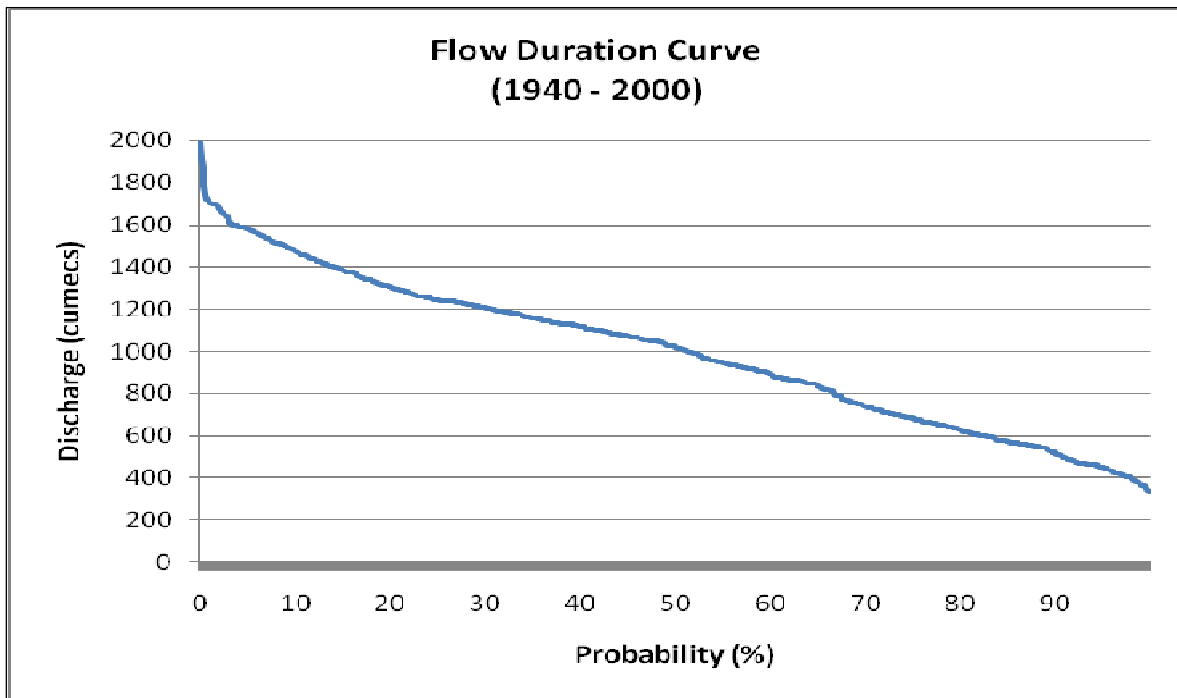
Figure 4.12: Flow duration curve for the Period 1940 - 2000

The flow duration curve using the monthly discharges of Kyoga Nile at Kamdini for the period 1940 – 2000 is given below in **Figure 4.12**.
