ANNUAL NATIONAL LEAD AGENCY ENVIRONMENT MANAGEMENT REPORT 2019/2020

JANUARY 2021

Annual national Lead agency environment management report 2019/2020

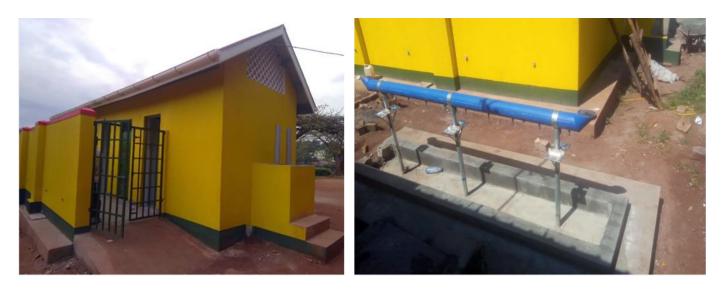
Figure 18: Kitante Primary School Bio-toilet

Figure 19: Installed WASHaLOT Block, Girls wing under the MTN Run forKampala Project Phase 2

Reduction of pupil to stance ratio: KCCA in partnership with GIZ- Sanitation for Millions project, Crane, Water Aid Uganda and MTN Uganda constructed and renovated water borne and bio-toilets in nine public primary schools (i.e. Kitante P.S, Kampala School for the Physically Handicapped, Kitebi P.S, Biina Islamic P.S, Luzira Secondary School, Kawempe Muslim P.S, Ttula C.O.U P.S, Railway Children P.S, and Kansanga Seed Secondary School. A total of nine toilets are being worked upon of which three are bio-toilets and the rest are water borne toilets. Figures 18 and 19 show some of the facilities constructed.
